**NASA Technical Memorandum 82956**

# **Ferrographic and Spectrometer Oil Analysis From a Failed Gas Turbine Engine**

**William R. Jones, Jr.**  
*Lewis Research Center  
Cleveland, Ohio*

**Prepared for the  
International Conference on Advances in Ferrography  
sponsored by the University College of Swansea  
Swansea, United Kingdom, September 22-24, 1982**

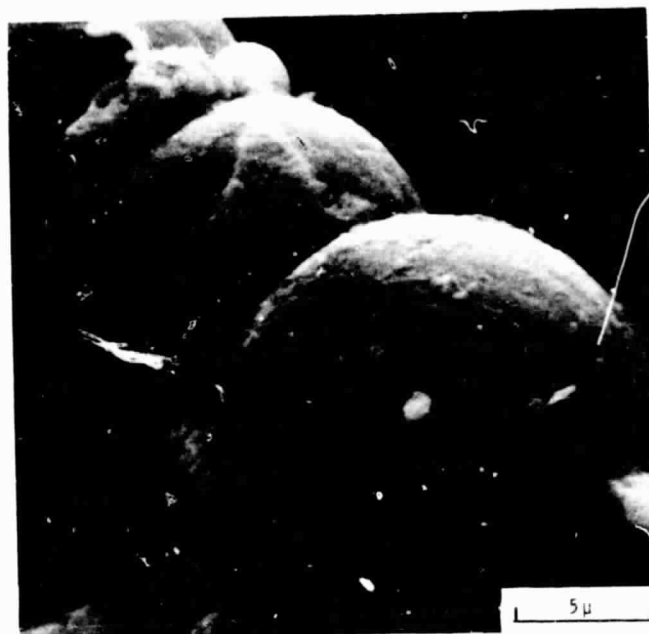
(a) Electron micrograph of spherical particles.

Figure 2. - Spherical particles from oil sample 9/10/76 (before failure).

The particle morphology of figure 1(a) is essentially that of normal rubbing wear particles (a benign form of wear) (refs. 7 and 8). However, there were spherical particles evident in the prefailure sample and an electron micrograph appears in figure 2(a). EDX analysis of the spheres appears in figure 2(b) and the background analysis of the glass Ferrogram appears in figure 2(c). The presence of Au is due to the evaporated Au film to prevent charging in the SEM. These spheres are essentially pure Fe. No other elements (besides the background elements) are detected by EDX. These large 10- to 15- $\mu$ m-diameter spheres are probably contaminants in the oil. Spherical particles have been related to bearing fatigue (refs. 7-10), but spheres from fatigue are usually much smaller (1 to 5  $\mu$ m in diameter) and have analyses similar to the bearing steel. Large spheres have been associated with cavitation erosion (ref. 8) and grinding (ref. 11).

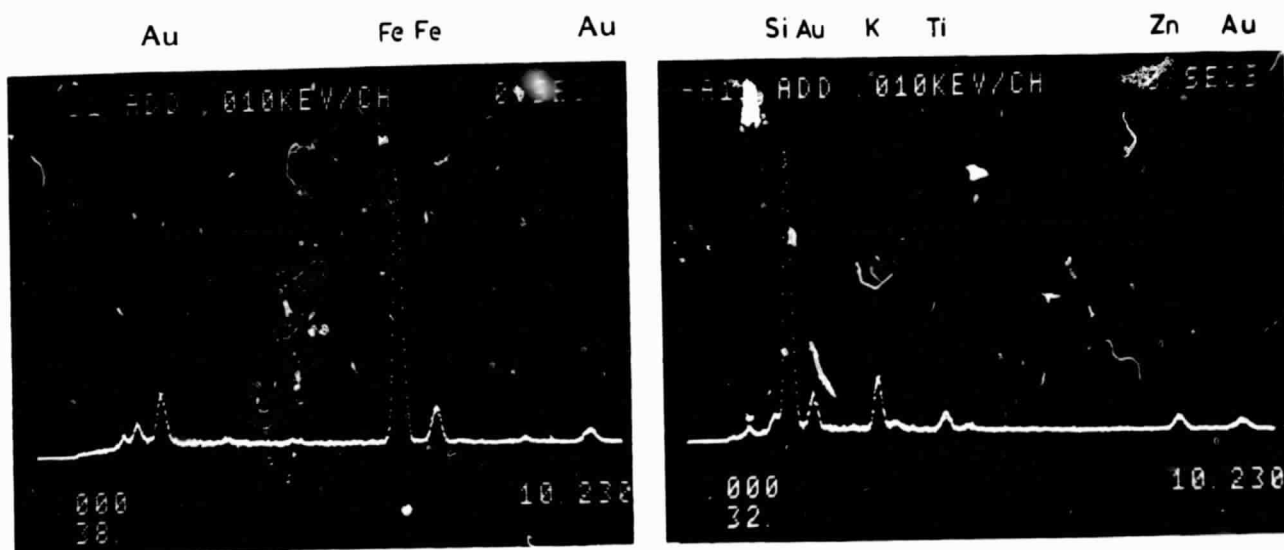
(b) Energy dispersive X-ray analysis (EDX) of spheres.

(c) Background EDX of ferrogram.

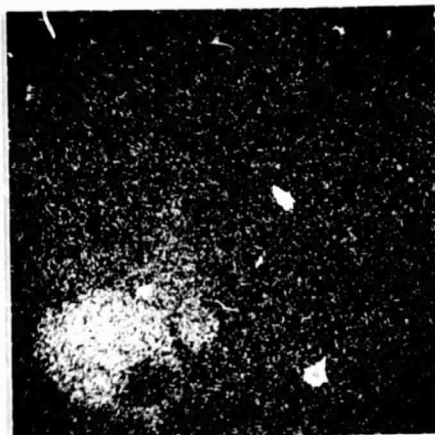
(a) Electron micrograph of spherical particles and debris

(b) X-ray distribution of Fe.

(c) X-ray distribution of Ti.

(d) X-ray distribution of Cu.

(e) X-ray distribution of Si.

Figure 3. - Spherical particles and debris from oil sample 9/10/76 (before failure) and accompanying elemental X-ray maps.

Essentially the same area on the Ferrogram that appears in figure 2(a) is mapped for the distribution of Fe, Ti, Cu, and Si in figures 3(b) to (e). As can be seen, the majority of the particles contain Fe, while one particle contains Ti. Most of the Si and Cu is from the background.

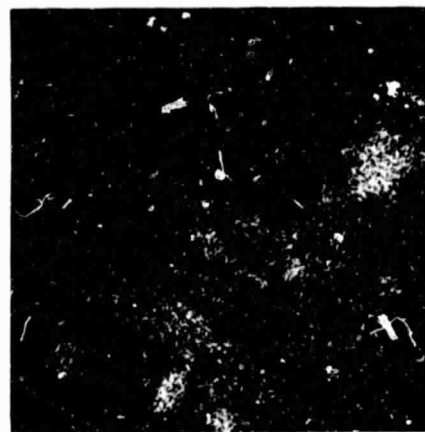
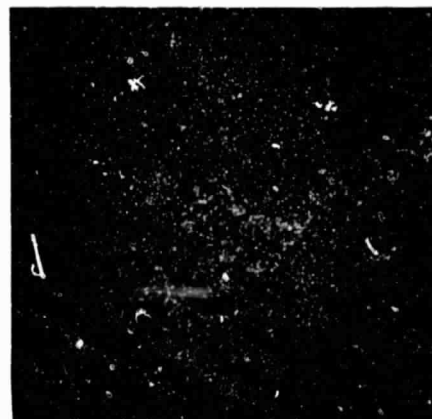
(a) Electron micrograph of debris.

(b) X-ray distribution of Ti.

(c) X-ray distribution of Fe.

(d) X-ray distribution of Ni.

(e) X-ray distribution of Cr.

(f) X-ray distribution of Si.

Figure 7. - Debris from oil sample 9/14/76 (after failure) and accompanying elemental X-ray maps.

Another micrograph of debris from engine sample (September 14, 1976) is shown in figure 7(a). X-ray distribution maps for Ti, Fe, Ni, Cr and Si appear in figures 7(b) through (f), respectively. In support of the previous figure, the debris consists of Ti and Fe with small amounts of Ni and Cr. The Si is essentially from the Ferrogram slide.

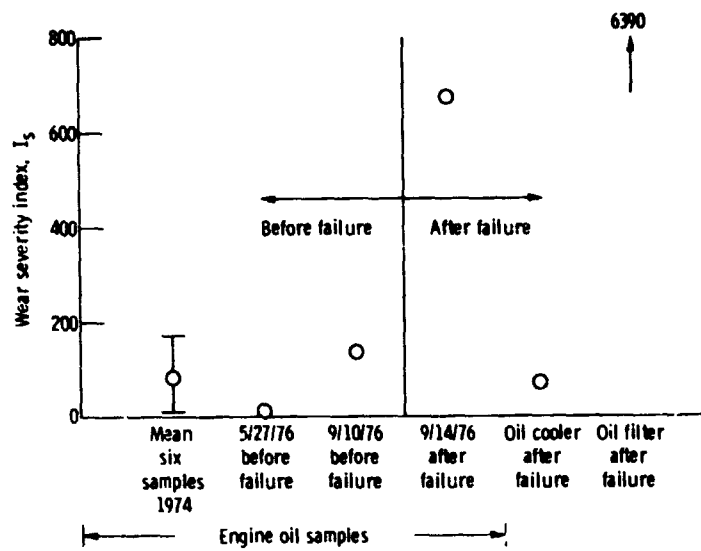
Figure 8. - Wear severity index ( $I_s$ ) for various oil samples.

Wear severity index. - A parameter, the wear severity index, has been advocated by Bowen and Westcott (ref. 7). This parameter is calculated from optical density measurements made at the entry position of the Ferrogram ( $A_L$ ) and at the 50-mm position ( $A_S$ ). These are the areas covered by the large and small particles. Their sum ( $A_L + A_S$ ) yields the general level of wear, while their difference ( $A_L - A_S$ ) gives an indication of abnormality. These two quantities multiplied together  $(A_L + A_S)(A_L - A_S)$  yield the wear severity index  $A_L^2 - A_S^2$ , usually abbreviated  $I_S$ .

$I_S$  values for all of the oil samples, including the mean and standard deviation of six engine samples from 1974, are shown in figure 8. The  $I_S$  increased from about 10 to 140 from the May 27, 1976, sample to the September 10, 1976 sample. Although this is a large increase prior to failure, it is not significant when compared to the range of  $I_S$  values obtained from this engine in the past (i.e., 1974 samples). After failure,  $I_S$  values increase dramatically. This, of course, is expected. An especially large value was obtained from the oil filter sample.
